# Discussion on the Principle and Reliability Improvement of AC Magnetic Flux Leakage Detection of Steel Rod

Baishang Hu. Discussion on the Principle and Reliability Improvement of AC Magnetic Flux Leakage Detection of Steel Rod. *American Journal of Physics and Applications*. Vol. 7, No. 2, 2019, pp. 48-54. doi: 10.11648/j.ajpa.20190702.13

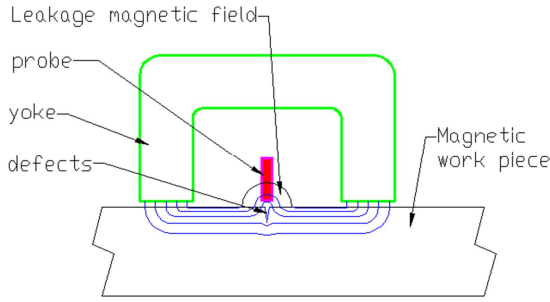
Figure 1. Formation of leakage magnetic field

The workpiece is magnetized by the excitation source (magnetic yoke) during Direct current (referred to as DC) MFL detection. Under ideal conditions, all magnetic field lines pass through the workpiece and almost no magnetic flux leaks to the workpiece surface. Once there is a defect on or below the surface of the workpiece, the magnetic field near the defect is compressed so that the density of the magnetic field

line at that point increases, then the magnetoresistor near the defect increases, and finally the magnetic field is distorted. As a result, most of the magnetic field lines bypass the defects in the workpiece, and a small part passes through the defects, and some parts leave the workpiece surface to form a leakage magnetic field in the air around the defects [4] 41-42 [5] 31-33 [6], as shown in Figure 1. Leakage magnetic field is detected by magnetic sensor and converted into electrical signal. After amplification and filtering, defect signals and acousto-optic alarm are given, and the defect is finally detected [3] 82-87 [6] [7].

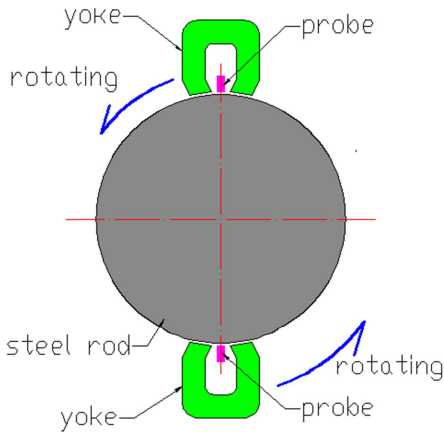
Figure 2. Probe scanning on steel rod surface

The MFL detection method of steel rod is shown in Figure 2. In the process of detection, the steel rod advances along a straight line, and a pair of magnetic yoke and a pair of probes are set symmetrically on the axis of the steel rod to rotate around the steel rod to realize the spiral sweep of the surface of the steel rod. High-frequency alternating current (referred to as AC) magnetization method is used for MFL detection of steel rods. High-frequency magnetization produces skin effect [8] [9], making most of the magnetic field pass through the surface area of the steel rod. In this way, the surface area of the bar under the magnetic yoke can be saturated magnetized. Once there is a defect in the surface area of the steel rod, part of the magnetic field near the defect is immediately squeezed out of the surface of the rod to form a leakage flux [3] 20-21 [4] 12-13 [5] 36-37.

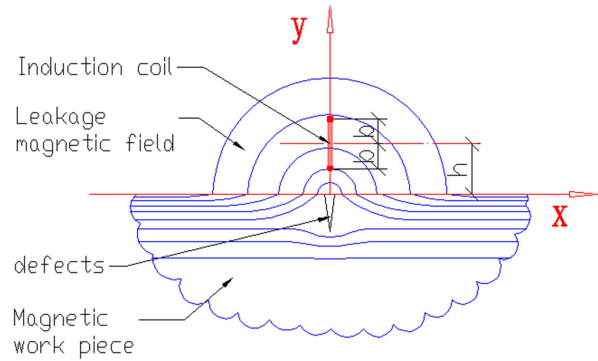
Figure 3. The induction coil scans the leakage field of the defect

rod, and the signal of the defect is obtained through the electromagnetic induction between the coil and the MFL during the detection process. Usually, The coil is placed perpendicular to the surface of the steel rod and the horizontal component of the defect leakage magnetic field is collected during detection [3] 79-80, 95-96 [7, 10-13]. as shown in Figure 3). If a narrow crack on the surface of the steel rod is detected, the horizontal component  $B_t$  of the spatial distribution of the MFL can be represented by a simple approximate formula (1) [14]:

In the formula:  $w$  is the longitudinal width of the crack,  $m$ ;  $B_0$  is the flux density at the bottom of the defect,  $wb/m^2$ ;  $x$  is the horizontal distance from a point in the MFL to the center of the defect,  $m$ ;  $y$  is the vertical distance from a point in the MFL to the center of the defect,  $m$ ;  $f$  is the AC frequency,  $Hz$ ;  $t$  for the time,  $s$ .

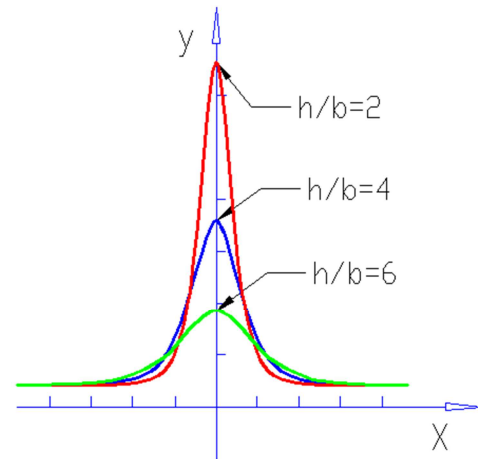
It can be seen from formula (3) that the maximum induced voltage of the coil is inversely proportional to the lift-off value of the coil for the MFL of the identified defect. The detection signal of the coil corresponds to different lift-off value  $h/b$ , as shown in Figure4. This confirms the statement "... When the lift-off value exceeds twice the crack width, the strength of the MFL decreases rapidly with the increase of the lift height" [3]. In terms of the  $h/b$  value versus the signal amplitude. MFL signal amplitude increases with the decrease of the values of  $h/b$  in figure 4, the ideal maximum is the lower side of the coil on the rod surface, the  $h/b = 1$ , but in the actual detection, induction coil encapsulation in wear-resistant boot (see figure 5), the distance between the induction coil and the rod surface is not less than the thickness of wear-resistant pieces, this limits the minimum value of  $h/b$ , in the process of testing for a long time, as wear-resistant pieces of thinning the minimum value for  $h/b$  becomes smaller, and higher detection sensitivity, but the noise will also rise to lower SNR, wear-resistant boot need to be replaced when SNR is not meet the requirements.

Figure 4. Effect of lift-off effect on the detection signal

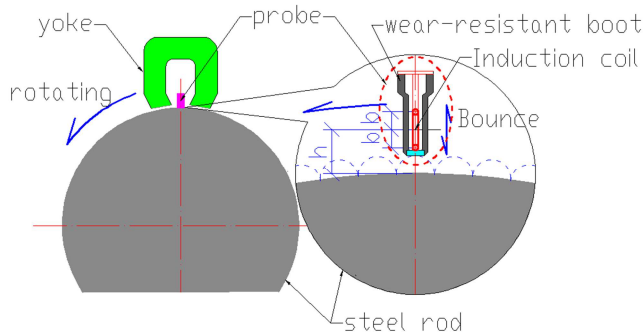
The probe consists of a wear-resistant boot and an induction coil inside. Ideally (the surface of the steel rod is smooth and has no longitudinal bending, and the probe is subjected to a uniform push pressure from the spring). The wear-resistant boot slides against the surface of the steel rod during detection. At this time, The coil is kept constant relative to the lift-off value  $h/b$  on the surface of the steel rod. When the detection parameters are unchanged, the same defect on the steel rod is repeatedly scanned and the signal amplitude formed is consistent. However, in actual testing, the probe is subjected to the combined effect of spring pressure, rotating centrifugal force, and support force on the rough surface of the steel rod. The wear-resistant boot bounds quickly on the surface of the steel rod and makes a clatter sound, as shown in Figure 5. The induction coil bounce with the wear-resisting boot, and the lift-off value ( $h/b$ ) is difficult to be constant when the induction coil is scanning the defect. The test result is that the detection signal value obtained from each scan is changed from the same defect. This creates uncertainty that the defect be effectively detected. The bounce of induction coil also

Figure 5. Probe bouncing in the process of scanning

Once a violent probe bounce occurs during the MFL detection of the steel rod, the defect may be missed or misreported, even if the conveyor rollers and the device have a good degree of consistency, and the straightness and roundness of the steel rod are in full conformity with the standard. It is difficult to eliminate the probe bounce in the detection process. The main reasons have been described before. Therefore, the deviation of the detection results caused by the probe bouncing is often referred to as the inherent deviation of the device. The characteristic of this inherent deviation is that the signal amplitude fluctuates within a certain range, and the range of this fluctuation depends on the amplitude of the probe bounce. It is easy to cause false alarm or missed inspection when the reference artificial injury signal is just past the alarm gate, but it will not cause a large defect missed inspection. In general, the appropriate sensitivity compensation is added to the verification sensitivity before the test is carried out to eliminate the risk of defects being missed.

The amplitude and span of the probe's bouncing are related to the rotation speed of the probe. They increase with the increase of the rotation speed, resulting in the increase of the lift-off effect, which shows that the accuracy and stability of the detection are poor. The rotation speed of the probe depends on the diameter of the steel rod and the detection speed in ensuring that the steel rod surface is fully covered. In addition, the scanning speed of the probe on the surface of the steel rod should not be too fast. Therefore, testing procedures should be developed for different diameter steel rods to overcome indirect effects of scanning speed. For example, care should be taken to reduce the detection speed appropriately for large diameter steel rods.

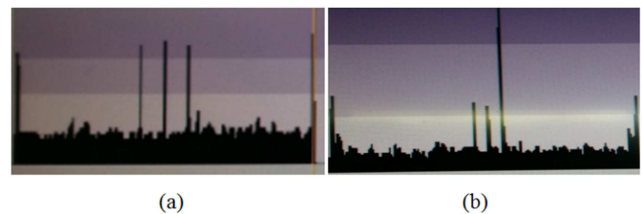
The concentric degree here refers to the coaxial degree of the center of the probe rotation and the center axis of the forward steel rod. The reliability of MFL detection is seriously affected by the concentric degree of the equipment. Figure 6a shows the scanning signal with uniform circumferential sensitivity, (In Figure 6, the horizontal direction indicates the direction of the length of the sample bar, the vertical direction indicates the amplitude of the scanning signal, and the

regional color difference represents the range of the amplitude used to evaluate the severity of the signal. Figures 8 and 9 are similar to this figure). There are many factors that affect the coaxiality. First, there are inconsistencies in the positioning of the center of rotation of the probe and the axis of the steel rod center by the transmission roller, which make the difference of circumferential sensitivity too large, as shown in Figure 6b. At this time, It is easy to cause false alarm on the side of the probe close to the steel rod, and it is easy to cause leakage on the side of the probe far from the steel rod. The second is that the linear path of the roller channel is not good, which causes the steel rod to beat when it is transmitted, thus causing the instantaneous lift-off effect of the probe, and the instantaneous lift-off effect increases with the deterioration of the transmission rollers path linear and the increase of the transmission speed. There is an increased chance of missing and misreporting. The third is that the centring roller and the transmission V-type roller before and after the host are worn after the equipment has been running for a long time, resulting in the deterioration of the coaxial degree of the equipment and the shaking of the steel rod in the transmission.

Figure 6. The difference of circumferential direction signal caused by the deterioration of the concentric degree

Specific measures to repair the equipment are taken to improve the coaxiality of the equipment and the transmission rollers based on the reasons described above. For example, the coaxiality of the roller channel relative to the center of the probe rotation is regularly adjusted, and the linear line of the roller channel transmission path is regularly calibrated. The wear condition of conveying and axial setting roller is checked in due course, and the badly worn roller is replaced in time.

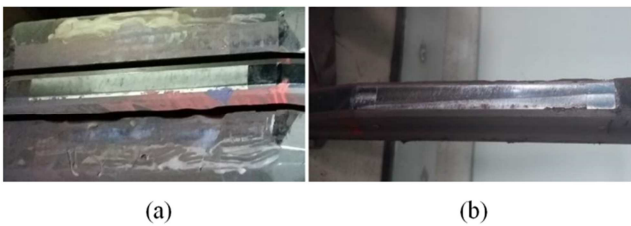
Normally, the wear-resistant boot is parallel to the axis of rotation and points vertically to the center of rotation, but if the wear-resistant boot is not assembled or operated in accordance with the above requirements, such as the wear-resistant boot deflection or tilt relative to the axis of rotation. This leads to uneven lift values and inconsistent sensitivity of the coils on both sides of the probe, as well as differences in sensitivity between different coil channels in a set of probes. As shown in Figure 7, it can be seen from the wear condition of wear-resistant boots that Figure 7a shows the normal wear state, while Figure 7b shows the abnormal wear state.

Figure 7. Wear of wear - resistant boots

The countermeasures for the above anomalies are to check the wear condition of wear-resistant boots frequently, adjust the position accuracy of wear-resistant boots according to the sensitivity difference of each channel, and conduct static balance calibration for all coil channels of the probe.

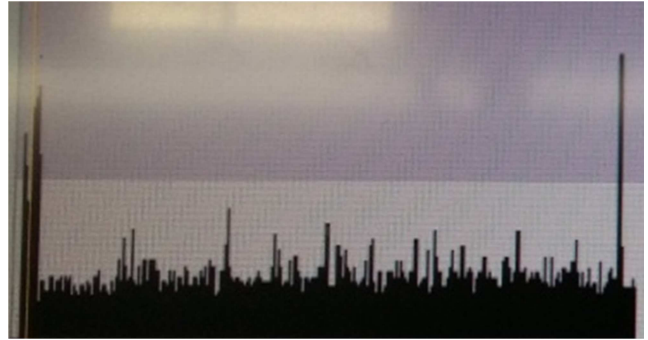
The bending of the steel rod includes the bending of the head and/or tail and the bending of the central axis. Coaxial deviation occurs when the local bending part of the steel rod passes through the rotating body of the MFL detection equipment. The detection sensitivity of the convex side of the steel rod is on the high side, and the possibility of false alarm is large, while that of the concave side is on the contrary. If there is bending of the head and tail of the steel rod, the impact will be greater, because the head and tail bending will not only lead to false alarm signal (as shown in Figure 8), but also impact the three-claw roll to loosen or damaged due to the eccentric entry and exit of the steel rod. As a result, the unsteady clamping of the three-jaw roller on the the steel rod, the vibration of the steel rod intensified. At the same time, excessive bending of the steel rod head and tail may also damage the rotating wear-resistant boots. The solution to this problem is to install a strict "watchdog" guide in front of the device to limit over-bent steel rods entering the device and tighten the three-claw rolls before and after the device to reduce the vibration of the steel rods appropriately.

Figure 8. Alarm signal caused by the bending of the head and tail of the steel rod.

When a small diameter steel rod (usually less than  $\Phi 30$  mm) is detected, it is easy to produce a head and tail swing due to the lack of rigidity. When the three-jaw roller is loose, the swing of the steel rod is more serious, because when the head of the steel rod enters into the detection device, only the three-jaw roller at the entrance holds the steel rod, and the roller at the exit is not working. Similarly, only the three-jaw roller at the exit holds the steel rod, and the roller at the entrance has been separated when the end of the steel rod leaves the detection device. At these times, the steel rod head and tail easily free swing, resulting in missed or false alarm. Overcome method is to install a entry - guided sleeve (less than  $\Phi 28$  mm) and tighten the three - roll claw in the sleeve.

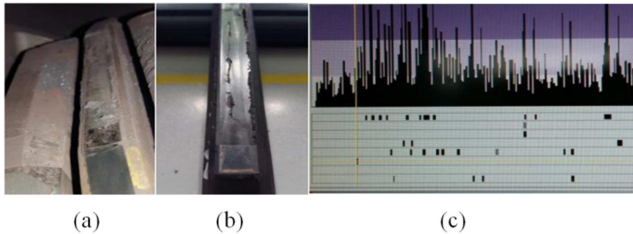
The distribution of the MFL around the probe changes when Oxide adsorption on the surface of the steel rod or the surface of the wear-resistant boots, thus the flux through the probe coil also changes. The effect is similar to the change of the coil lifting off, In general, the oxide skin is easily left on the surface of the rough steel rod, and iron oxide powder is easily attached to the pits and grooves on the surface of the rough steel rod. Dust and oxide powder are easily attached to the magnetic yoke and wear-resistant boots in the following situations: the vibration of the steel rod during transmission, the clamping of the three-claw roller before and after the host, the steel rod surface being hit by wear-resistant boots, and the magnetic field exists between the magnetic yoke and the steel rod. The MFL is mainly caused by the rough surface of the steel rod, and the oxidized powder with high magnetic conductivity is easily absorbed between the magnetic yoke and the wear-resistant boots (as shown in Figure 9a) or enters into the crack of the damaged wear-resistant boots (as shown in Figure 9b) to form a alternating magnetic poles, resulting in disorderly noise, poor SNR, and even serious false alarm, as shown in Figure 9c. (In Figure 9c, the horizontal position of the small points distributed in the lower half corresponds to the axis position and length of the defects on the bar, and the longitudinal position represents the circumferential expansion position corresponding to the orientation of the steel rod section where the defects are located. The yellow line is the timely coordinate line of the manual click signal) Because the concentrated oxide powder has a polymerizing effect on the

Figure 9. The condition of wear-resistant boots and false alarm caused by the oxidation and powder

weak magnetic field around the wear-resistant boots [3] 79 [6]. The countermeasure of the above problems is to improve the surface finish of steel rod during straightening. Compressed air and electric brush are used to remove residual oxides on the surface of the steel rod. Purge and clean the detection device timely; Discover and replace damaged wear - resistant boots in time.
